Kurla hotel blaze: 'False ceiling collapsed on diners'

Blatant irregularities at City Kinara, in total defiance of safety rules, included stored cylinders and pantry in Family Room on mezzanine where the unfortunate 8 were seated

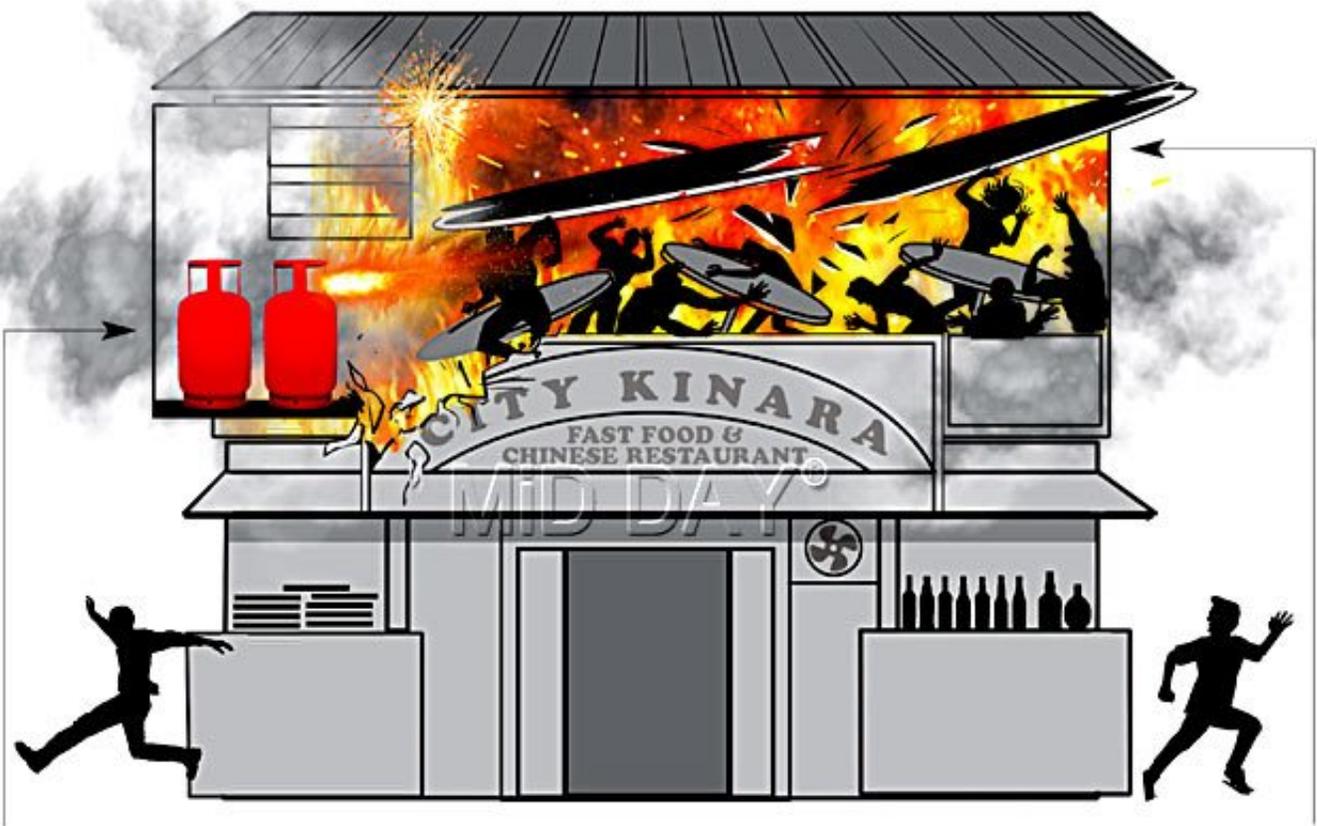
Two gas cylinders were stored in the mini pantry on the first floor. A leak in one of the cylinders went unnoticed by the staff. A short circuit in the overhead wires caused the fire

The impact of the inferno was such that the false ceiling melted and fell on the victims, trapping them on the first floor.

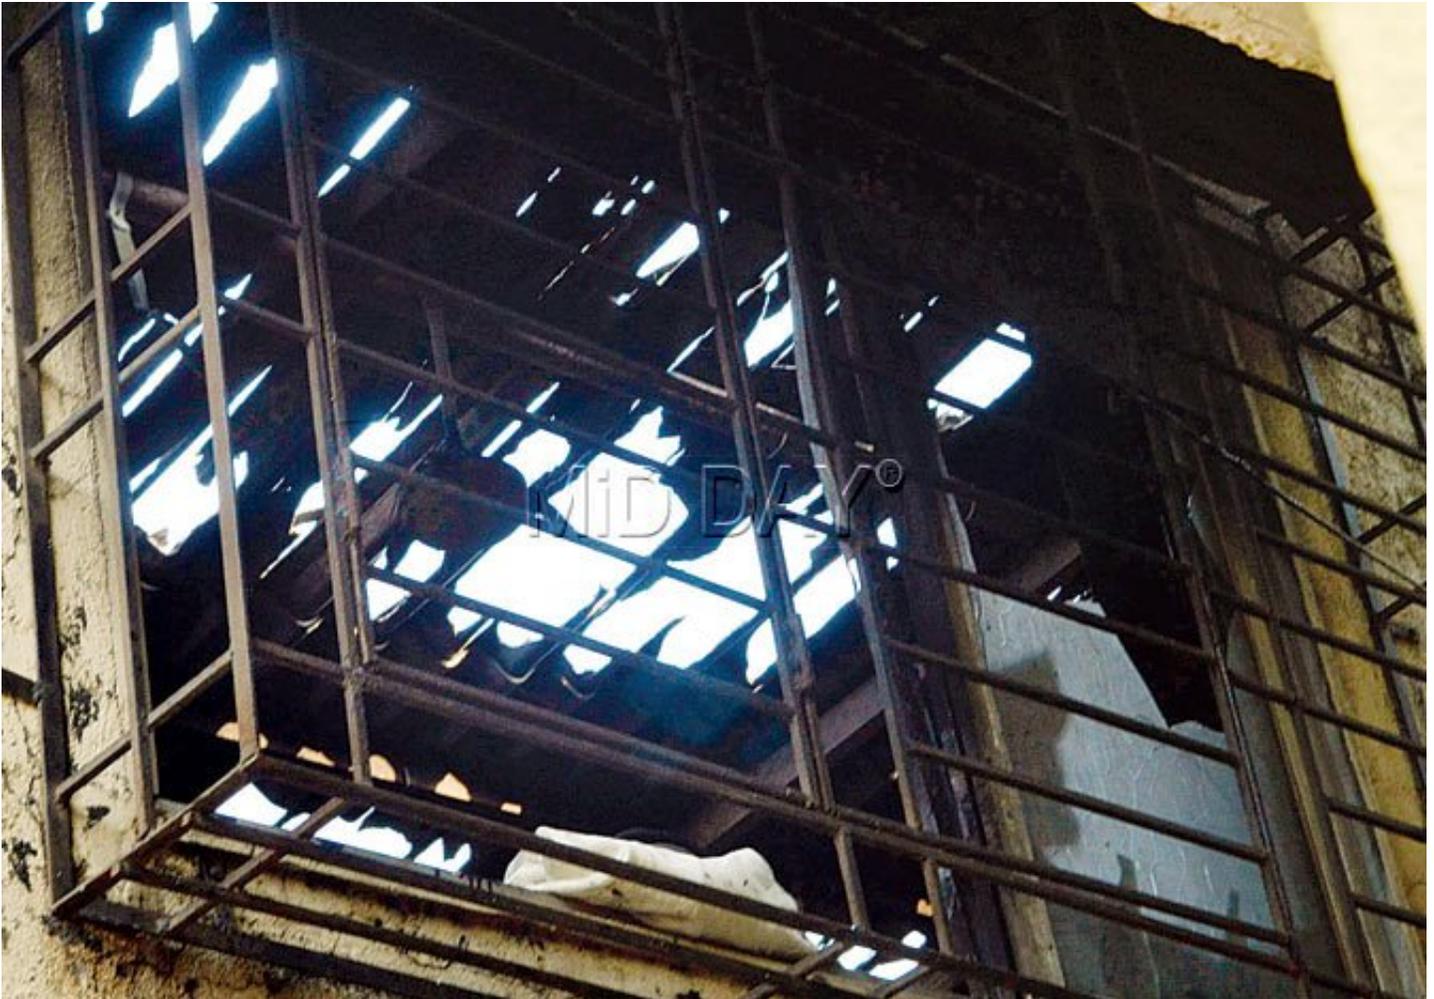
The damaged roof. Pic/Datta Kumbhar

With two fire engines and two water tankers arriving at the spot, the fire was doused within an hour. The tin roof, walls and furniture were all charred, say onlookers.
